06/07/2023

RE: Structural Evaluation Observations and Recommendations of the Mosaic School Building at 1499 W. Main St. in Decatur, Illinois.

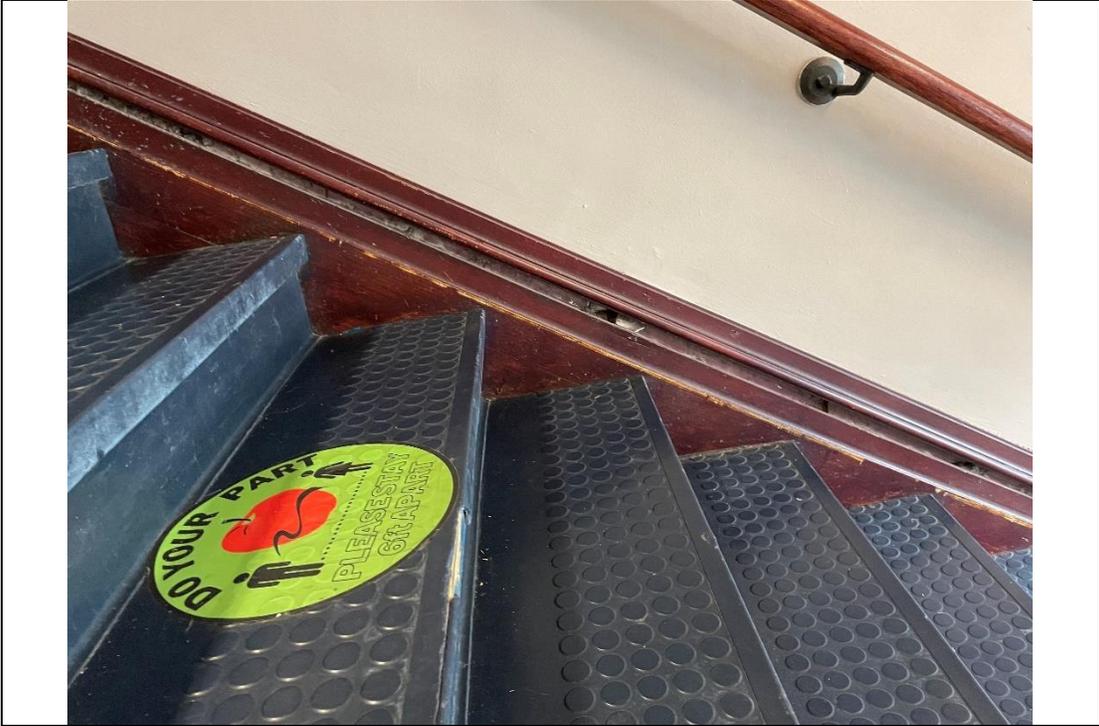
1. The stair flight of the north stair that runs from the vestibule level up to the 1<sup>st</sup> floor level is approximately 13'-6" wide with a handrail in the middle of the stair. The stringers are constructed out of notched out 2x12 timber members. Excessive permanent deflection was observed on this stair flight with gaps between the wall closed stringer and the wall mounted trim. The gap was up to 1" at the middle of the stringer span of the west side and up to 1/2" at the middle of the stringer span of the east side. At one accessible portion below the west side of this flight of stair we observed previous attempts to repair some of the stair stringers using a sistered 2x4 or a sistered ripped down 2x12 stringer over a portion of the original stringers. It also appeared that an 8" steel W-beam was added at some time in the past was pocketed into and added brick support pedestals on the east and west ends. The steel beam and brick pedestals were likely not original to the building and were likely added at some time in the past to help support the header at the top of the lower stair and north end of the 1<sup>st</sup> floor landing joists. See attached Photos #1 thru #5.

Description	Photo of the stair leading from vestibule up to first floor level looking west showing the sag in the stair from the gap between the wall closed stringer and wall mounted trim.	<b>1</b>
Date	06/01/2023

**Klingner recommends replacing or repairing the stair flight that runs from vestibule level up to the 1<sup>st</sup> floor level. If repairing, we recommend the stairs be raised to the original elevation and either additional supports be added below to support the stringers at their mid-span or adequately sistering each of the stair stringers. We do not recommend use the basement slab to help support any stair repairs or replacements.**

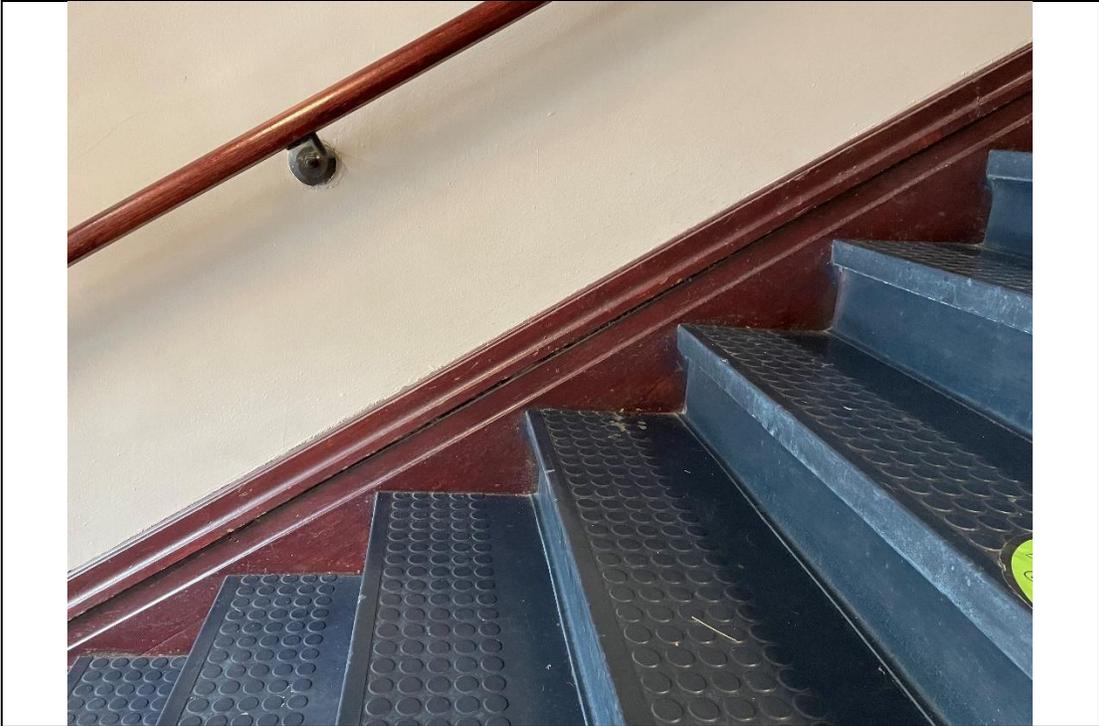
Description	Photo of the stair leading from vestibule up to first floor level looking east showing the sag in the stair from the gap between the wall closed stringer and wall mounted trim.	<b>2</b>
Date	06/01/2023

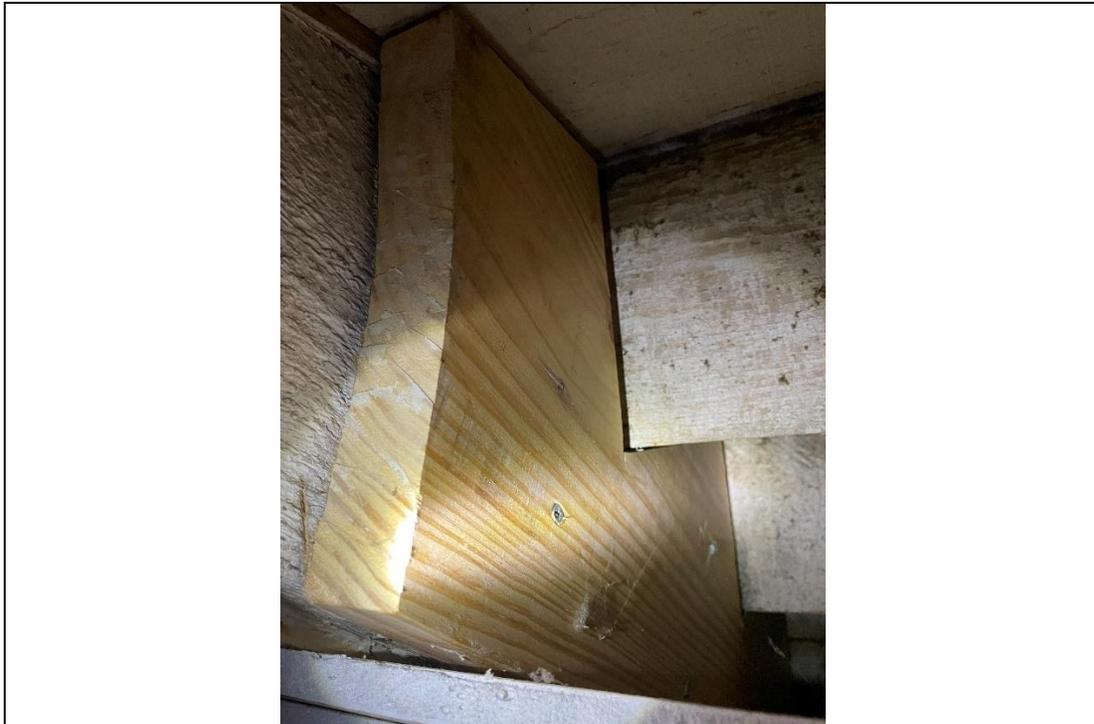
Description	Photo of a previous attempted repair to a stair stringer for the stair leading from vestibule up to first floor level near the west side of the stair.	<b>3</b>
Date	06/01/2023

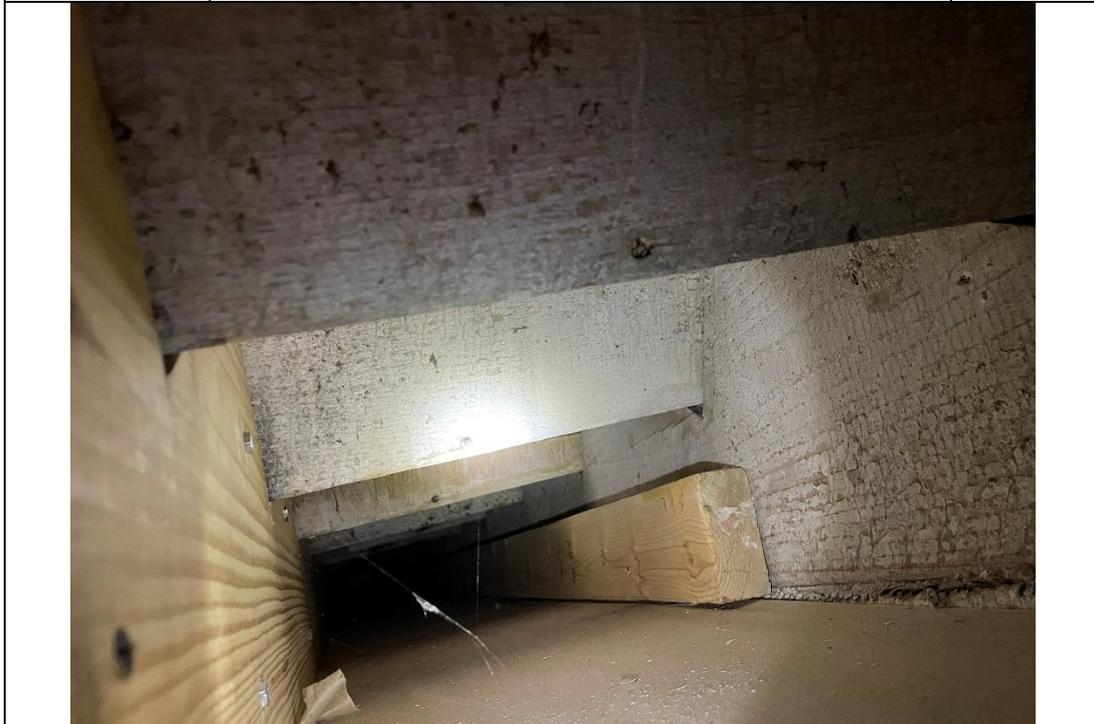
Description	Photo of a previous attempted repair to stair stringers for the stair leading from vestibule up to first floor level near the west side of the stair.	<b>4</b>
Date	06/01/2023

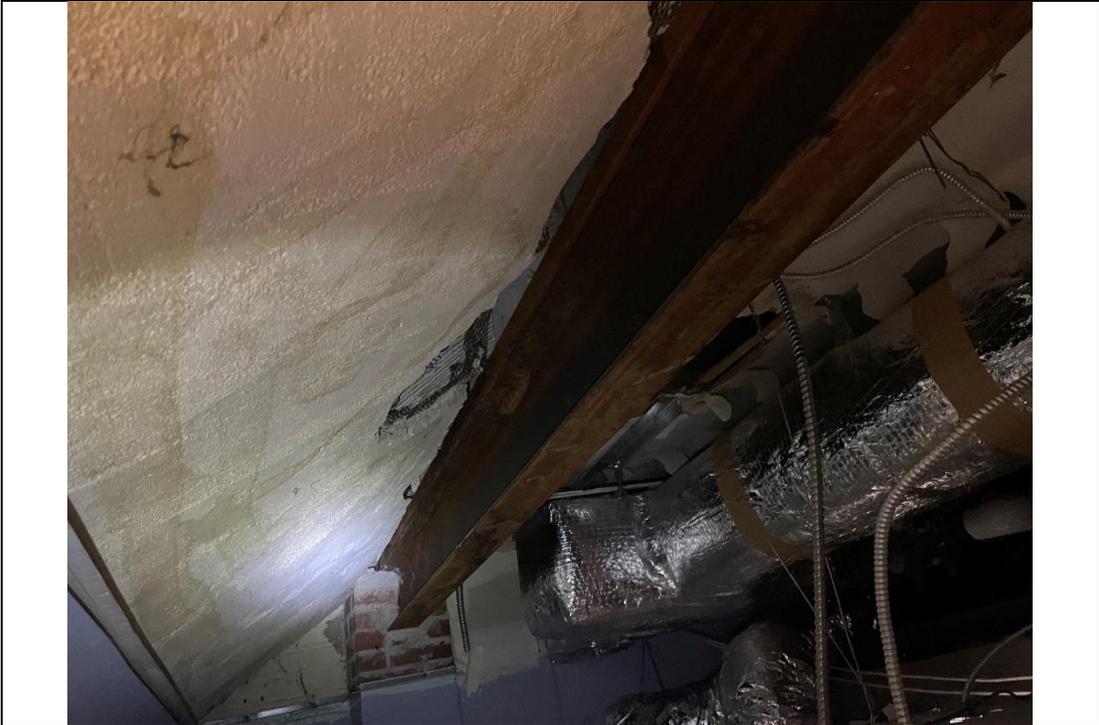
Description	Photo of an 8" steel beam that sits just below the upper end of the stringers for the stair leading from vestibule up to first floor level. This beam was likely added as a repair attempt sometime after the original construction.	5
Date	06/01/2023

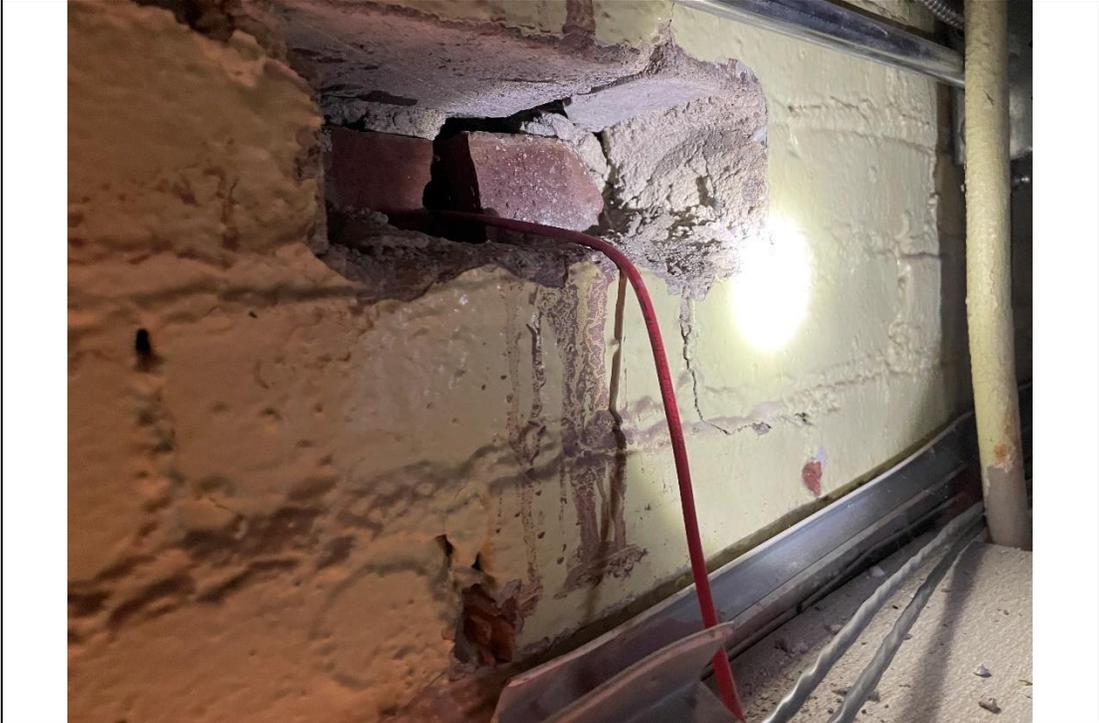
2. The multi-wythe brick walls on the east and west side of the vestibule and lower stair segment had portions of brick wall that had been removed for duct penetrations and cable penetrations. The larger duct penetrations appeared to have a header plate added to help support the brick wall portion above but the small single brick removals for cables did not. Some stair-step cracking extending off the ends of the brick openings and down to the existing brick wall door openings were observed. However, major signs of settlement or brick wall deterioration was not observed and it is unlikely that any of the structural concerns related to the north stair is related to the minor interior brick wall deterioration observed. See attached Photos #6 and #7.

Description	Photo of a vestibule wall near the corner of a man door opening that has had bricks removed to run a cable thru the multi-wythe brick wall. Brick crack steps down at edge.	6
Date	06/01/2023

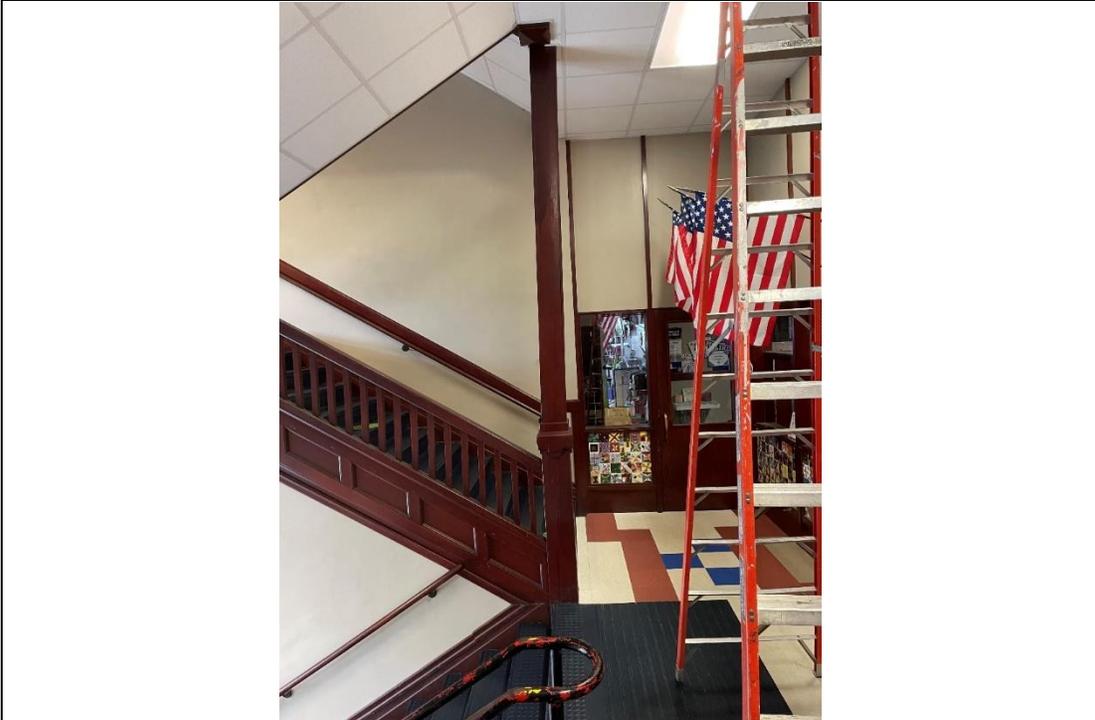
3. The two (2) timber column supports at the 1<sup>st</sup> floor landing that support the 2<sup>nd</sup> floor landing and stringer bearing are leaning or deflecting excessively in the north/south direction. It appears as if these two (2) columns are approximately 6x6 timber posts and were likely not original to the design of the stair and support system because they are not in the original plans or on the other middle stair

landing level that has similar short guardrail posts. It is possible that the columns were added at some time in the past as a repair attempt for the 2<sup>nd</sup> floor landing support header above. The columns are out of plumb excessively by approximately 2° in the north-south direction above the guardrail posts and do not appear to be adequately spliced or fixed to the guardrail portion of post below the column. The bottom guardrail post portion of column has 1x boards and trim surrounding the likely 6x6 timber post member that have splits and gaps running vertically on the east and west sides. The splits and gaps of the west column guardrail post surround is larger than the east column guardrail post surround. See Photos #8 thru #10 and #12.

Description	Photo looking at east column on the 1 <sup>st</sup> floor landing that is supporting the 2 <sup>nd</sup> floor above. Note the columns are out of plumb approximately 2° in the north/south direction and appears to start deflecting just above the top of guardrail.	<b>8</b>
Date	06/01/2023

**Klingner recommends replacing or repairing the 2<sup>nd</sup> floor landing header and sizing the new or repaired header strong enough to allow for the removal of the two (2) existing column supports above the 1<sup>st</sup> floor landing top of guardrail post and below the 2<sup>nd</sup> floor landing header. We recommend temporarily shoring and raising the landing back up to the original 2<sup>nd</sup> floor level until the header can be replaced or repaired. We also recommend repairing or replacing the 1<sup>st</sup> floor landing guardrail post after column supports are removed.**

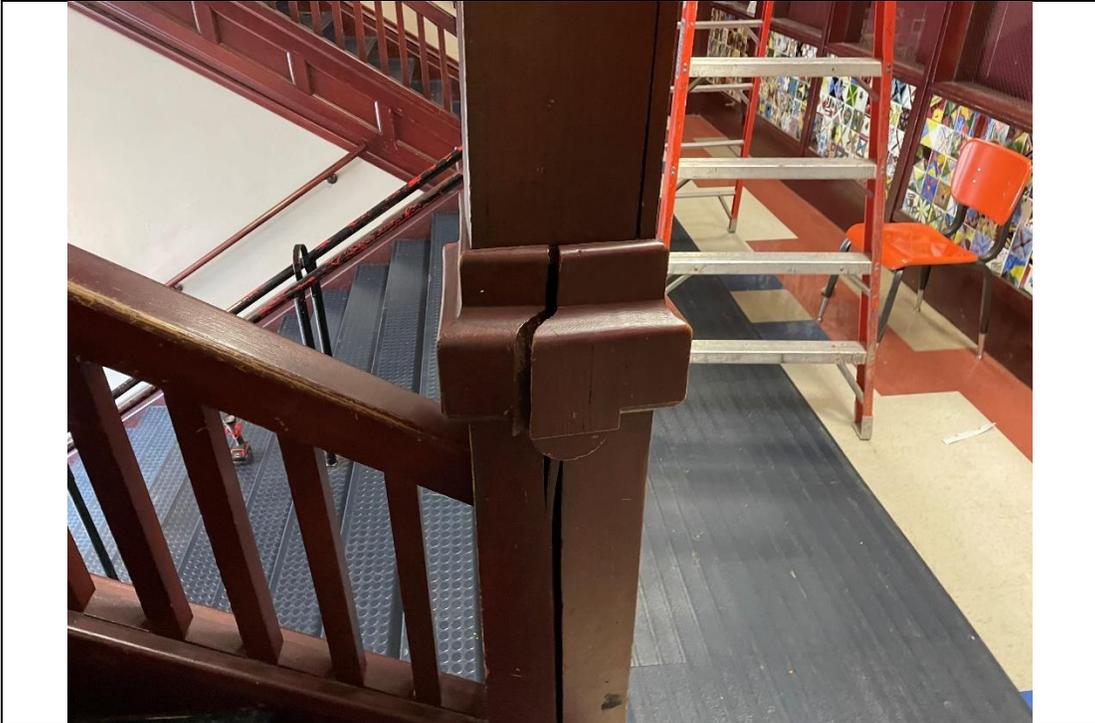
Description	Photo looking at west column at the 1 <sup>st</sup> floor landing. Note the 1x boards and trim surrounding the wood columns are split and gapped up to 1/2" from the column deflection.	<b>9</b>
Date	06/01/2023

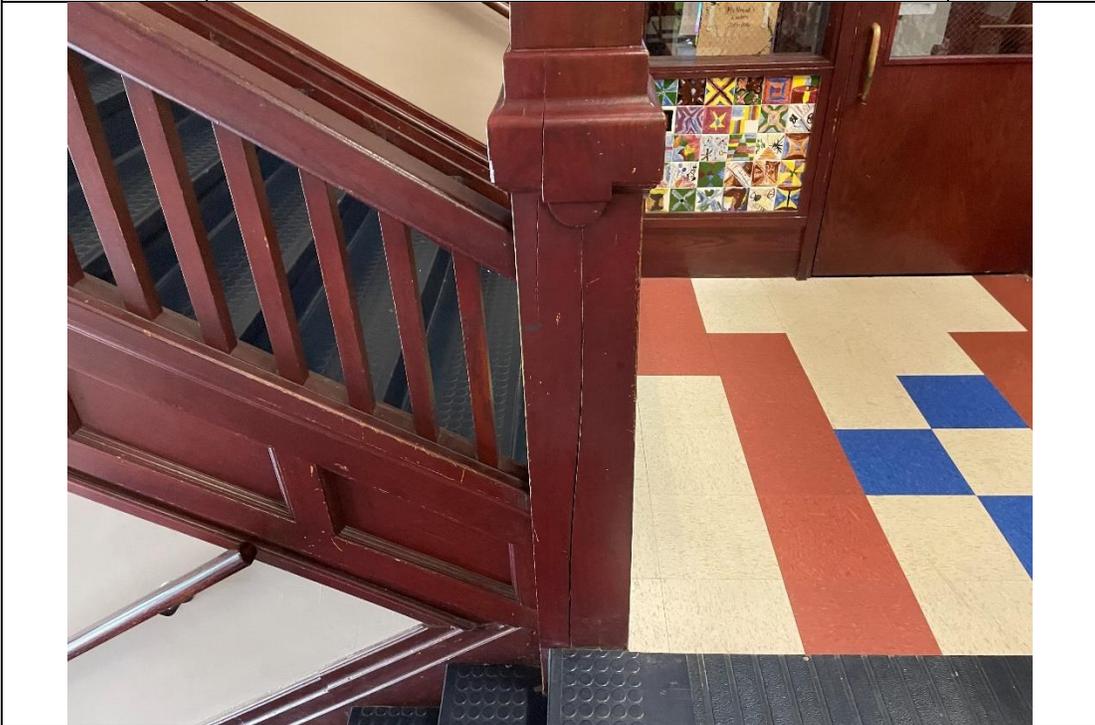
Description	Photo looking at east column at the 1 <sup>st</sup> floor landing. Note the 1x boards and trim surrounding the wood columns have multiple splits and gaps from the column deflection/kick out.	<b>10</b>
Date	06/01/2023

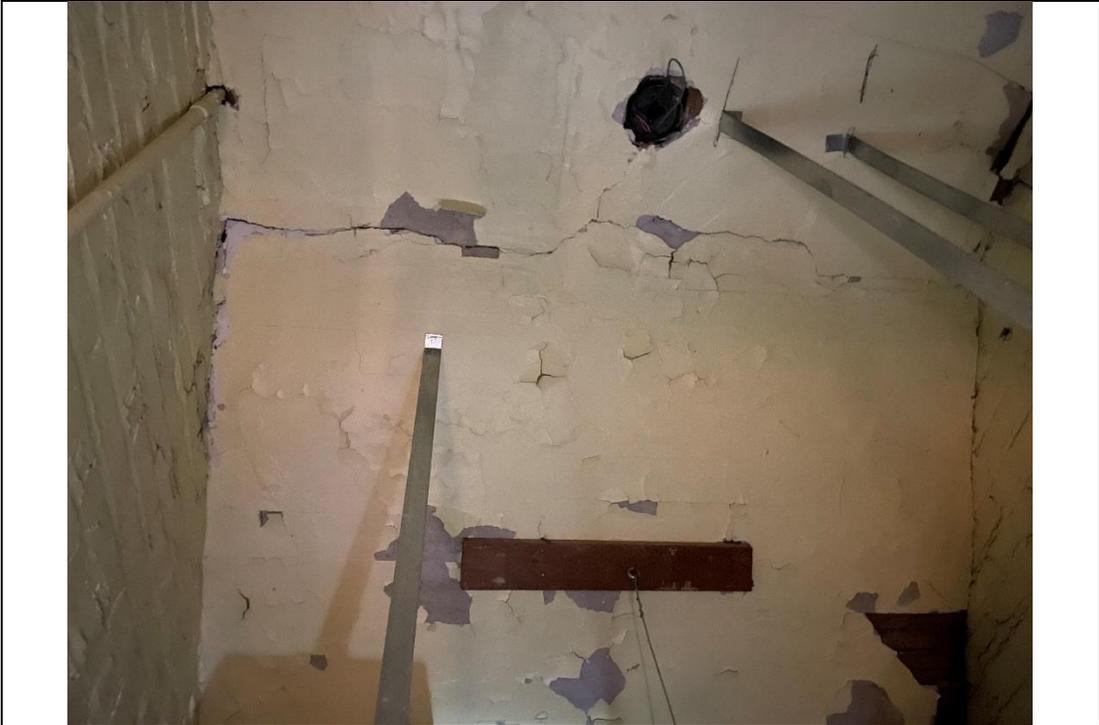
4. The bottom side of the east and west stair flight that runs from the 1<sup>st</sup> floor up to the middle landing was covered by plaster and lath. The plaster was missing and heavily cracked in areas below the east and west stair flight which is likely a sign of excessive deflections of the stair stringers or stringer header supports in the past. See attached Photo #11.

Description	Photo looking at the bottom side of the stairs that run from 1 <sup>st</sup> floor up to the middle landing. Note the plaster board cracking below the stair likely from the deflection of the stair stringers.	<b>11</b>
Date	06/01/2023

**Klingner recommends replacing or repairing the east and west stair flight that runs from 1<sup>st</sup> floor level to the middle landing. If repairing, we recommend the stairs be raised to the original elevation and adequately sistering each of the stair stringers. We also recommend replacing or repairing the middle landing header.**

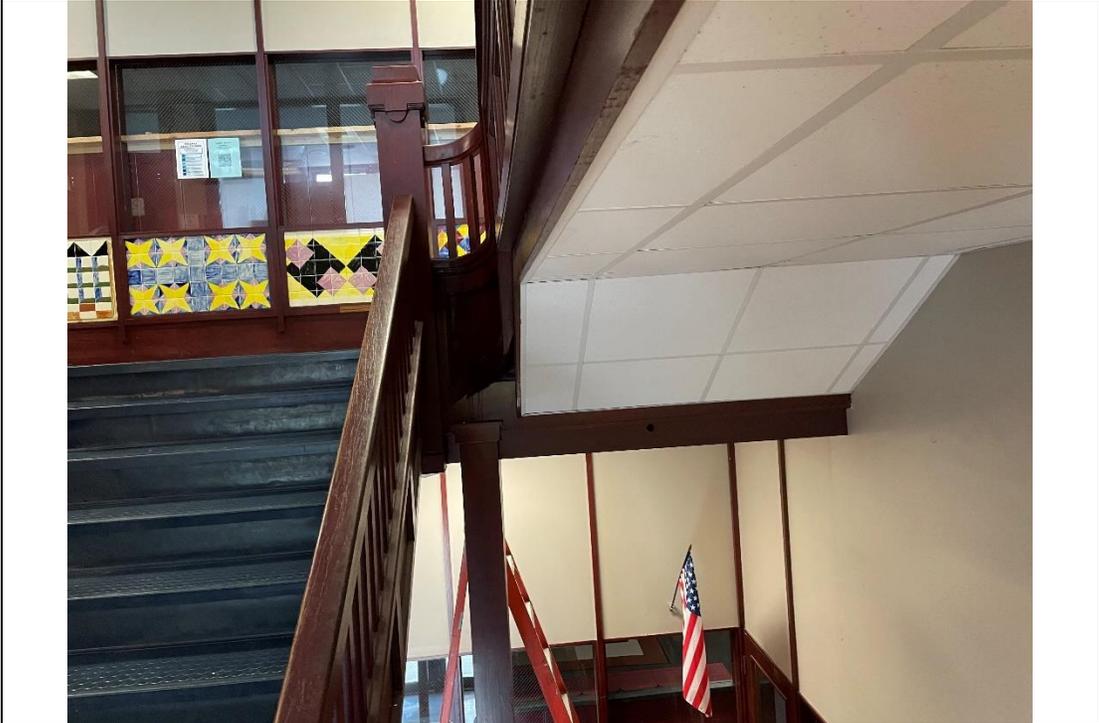
5. The 2<sup>nd</sup> floor landing header appeared to be a 3x14 timber member that spanned from east to west wall and was supported by the two (2) column supports below. In an accessible portion of the west end of header it appeared that the header was notched out for each of the 2<sup>nd</sup> floor joists that pocketed into the header with only the bottom 2" of header appearing to be continuous along the span of the header. This 2<sup>nd</sup> floor landing appears to deflect excessively, which may have been the reason why the column supports were likely added below it in the past. Even with the columns below, the header support on the north end of the 2<sup>nd</sup> floor landing appears to be inadequate. See the attached Photos #12 and #13.

Description	Photo looking at the 2 <sup>nd</sup> floor landing and at the small stair that leads to the upper level. Note the deflection of the stair and header that supports the bottom of the upper stair.	<b>12</b>
Date	06/01/2023

**See similar recommendations for Observation #3 above. Additionally, due to the similar size, span, and construction type of the stair flight that runs**

**from the middle landing up to the 2<sup>nd</sup> floor landing level, Klingner recommends replacing or repairing the stair flight. If repairing, Klingner recommends the stairs be raised to the original elevation and adequately sistering each of the stair stringers.**

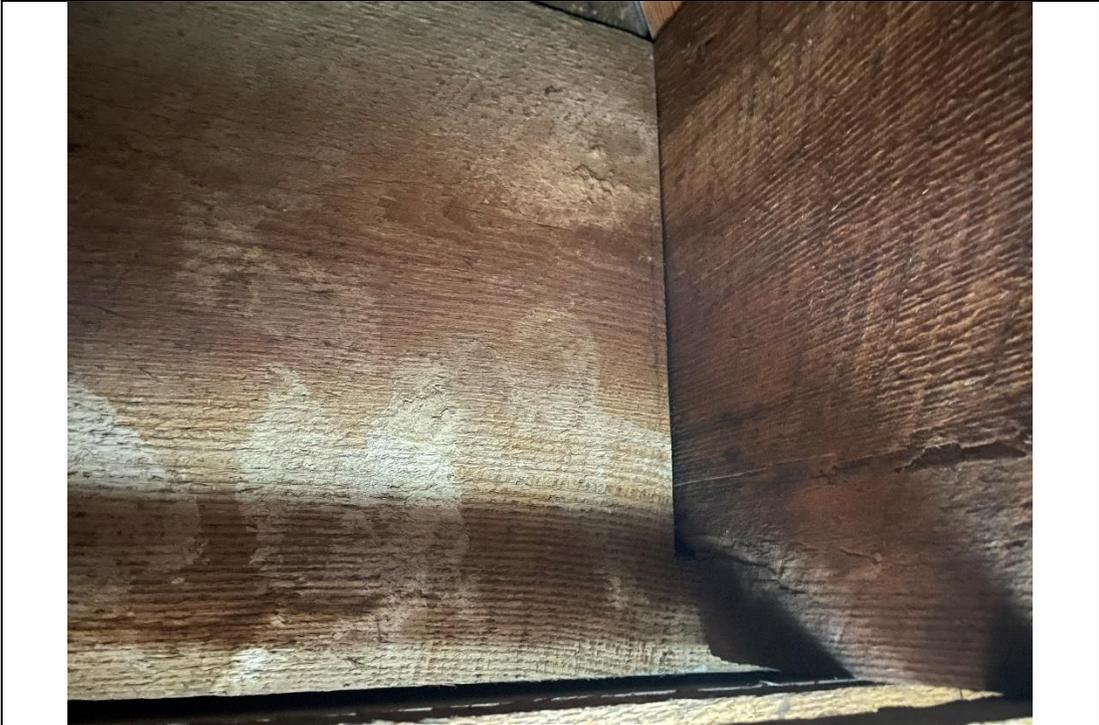
Description	Photo looking at the 2 <sup>nd</sup> floor header that supports the bottom of the stair from the upper level. Note the header was notched out for the 2 <sup>nd</sup> floor joists leaving only 2" of wood header member below each joist notch.	<b>13</b>
Date	06/01/2023

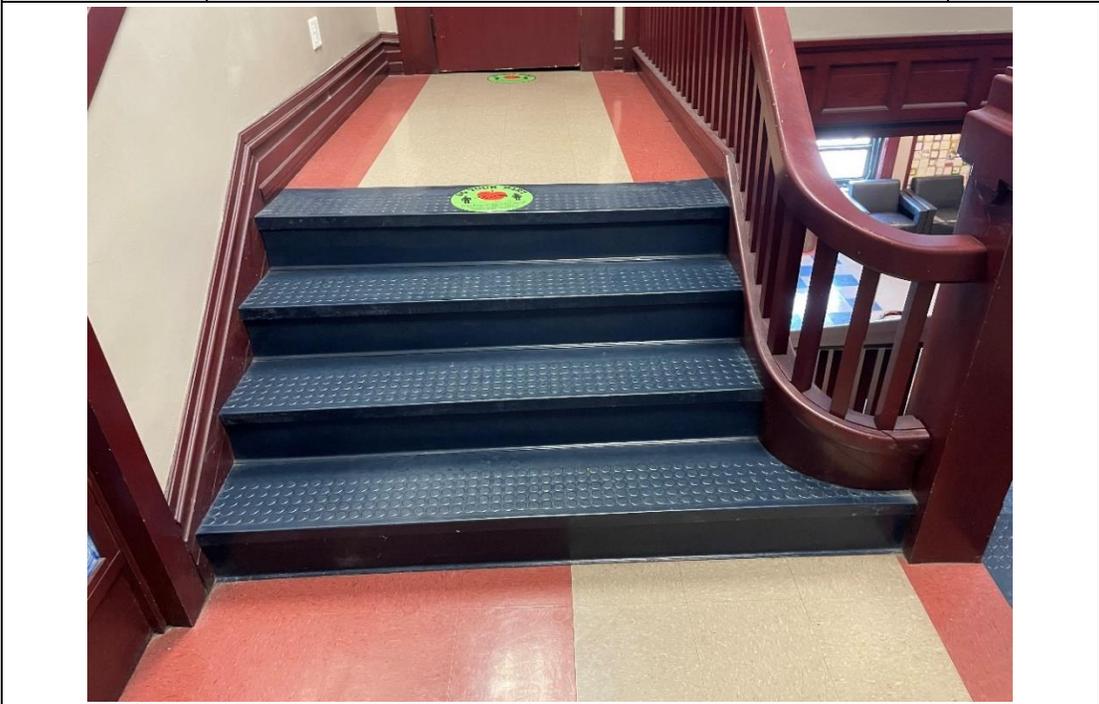
6. The east and west portions of upper stair flight are each approximately 5'-0" wide and run from the 2<sup>nd</sup> floor level up to the upper level that is slightly above the 2<sup>nd</sup> floor level. The upper level and both of these upper stair and stair landings have excessive deflection towards the middle of the stairwell or middle of header and upper-level floor joist span. The upper stair and stair landings are permanently deflecting at an approximately 2° slope and the doors leading to the room and staff restroom on the north end of the upper landings are out of plumb so much that someone has had to cut the door down to reduce the door height by up to 1" on the non-hinge side of the doors to allow the doors to be able to swing open. The wall on the south side of the upper landing is also deflecting near the mid-span and the wall plaster is cracking and the decorative wood trim along the base of the wall is splitting. While the upper-level framing spans in the east/west direction, with no column supports below the existing header that is located at the south end of the upper level, it appears the upper-level south header is inadequate to support the stair landings and the wall above it. See attached Photos #14 thru #17.

Description	Photo looking at the west small stair that leads to the upper level. Note the stair and landing deflects down 2° towards the east (right of photo) and the door beyond has been trimmed 1" to open.	<b>14</b>
Date	06/01/2023

**Klingner recommends replacing or repairing the upper landing header and raising the upper landing level and wall to the original elevation. We also recommend replacing or repairing the east and west stair flight and landing that runs from the 2<sup>nd</sup> floor level to the upper landing. If repairing, we recommend the stairs and landing be raised to the original elevation and adequately sistering each of the stair stringers. We recommend replacing the doors on the upper level after all repairs/replacement and raising has been completed.**

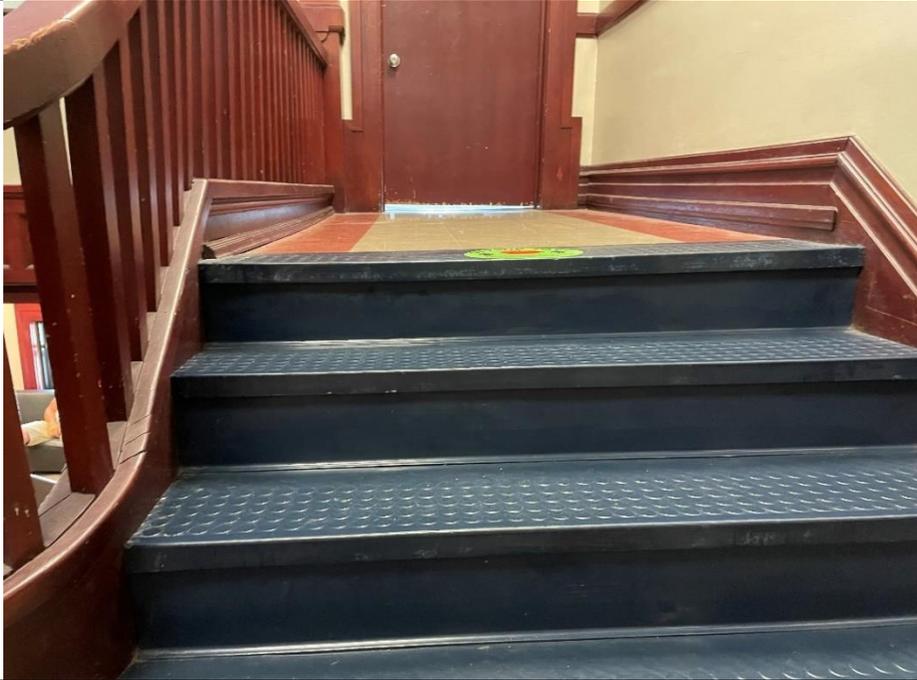
Description	Photo looking at the east small stair that leads to the upper level. Note the stair and landing deflects down 2° towards the west (left of photo) and the door beyond has been trimmed 1" to open.	<b>15</b>
Date	06/01/2023

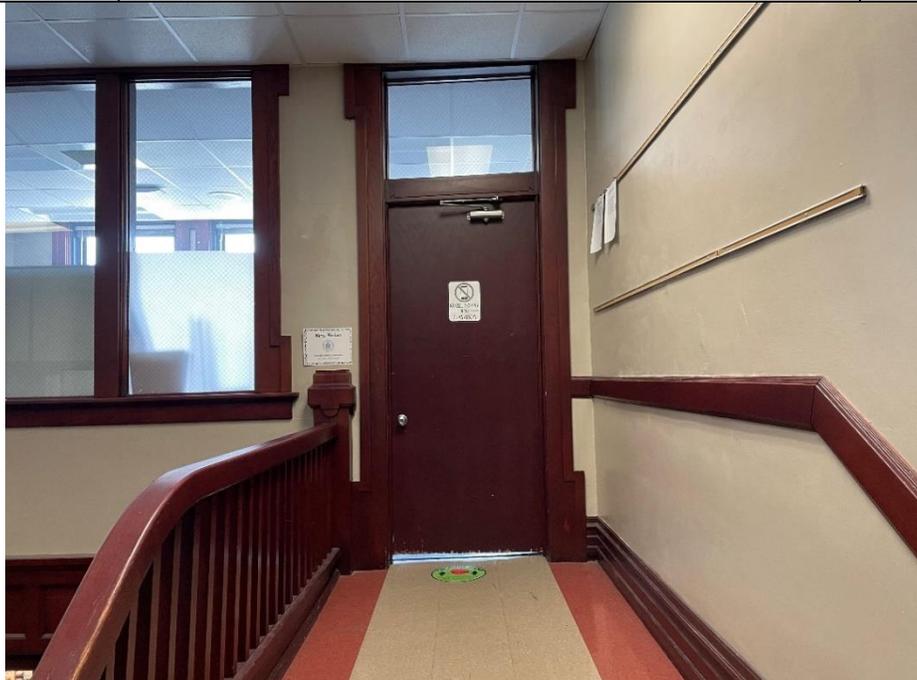
Description	Photo looking at the upper-level landing of the east small stair. Note how out of plumb the door and window above are and that the door has been trimmed down 1" to open.	<b>16</b>
Date	06/01/2023

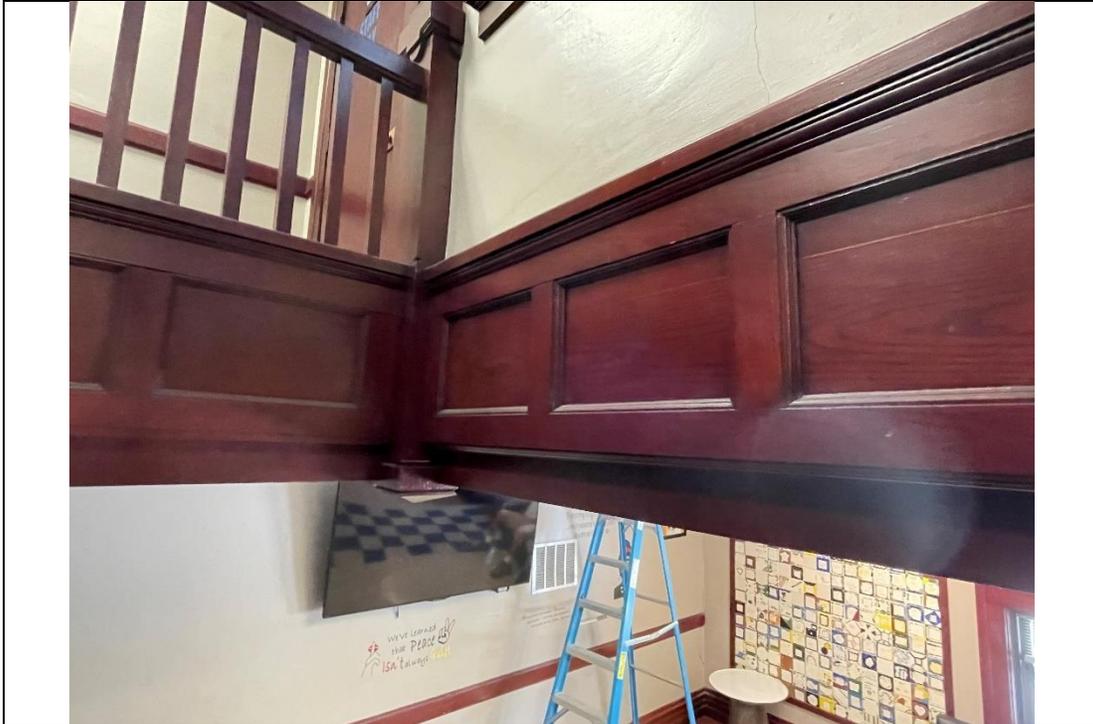
Description	Photo looking at the wall on the upper level between the upper-level stair landings. Note the wall plaster cracks and wall trim cracks from the excessive deflections of the wall.	17
Date	06/01/2023

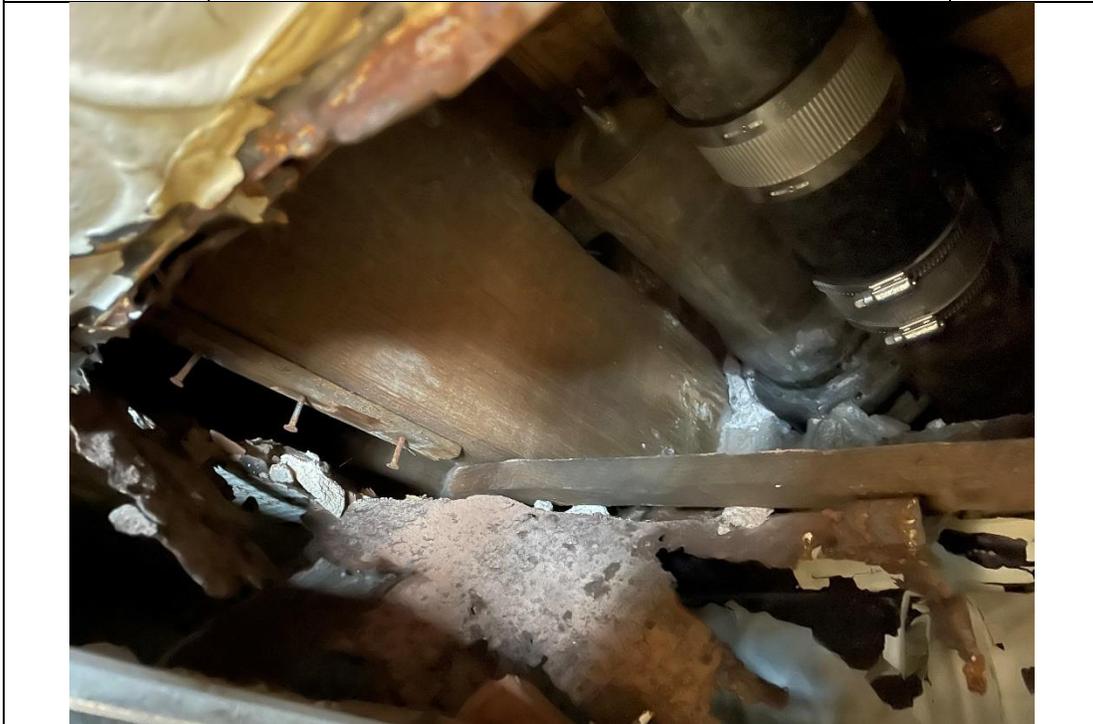
7. One of the exposed joists of the upper level has been notched for a previous plumbing penetration. There was also some minor existing water damage to the nearby joists and ceiling where it appeared a previous plumbing repair had been made. See attached Photo #18.

Description	Photo showing a previous notch cut out of one of the upper-level floor joists for plumbing penetration. Note this portion of ceiling appears to have been previously opened up to fix a plumbing pipe leak in the floor of the upper level.	18
Date	06/01/2023
