**BACON | FARMER | WORKMAN**

Re: Dennis Lab School Inspection (Kaleidoscope)  
1499 W Main St  
Decatur, IL 62522  
BFW Project No. 23418

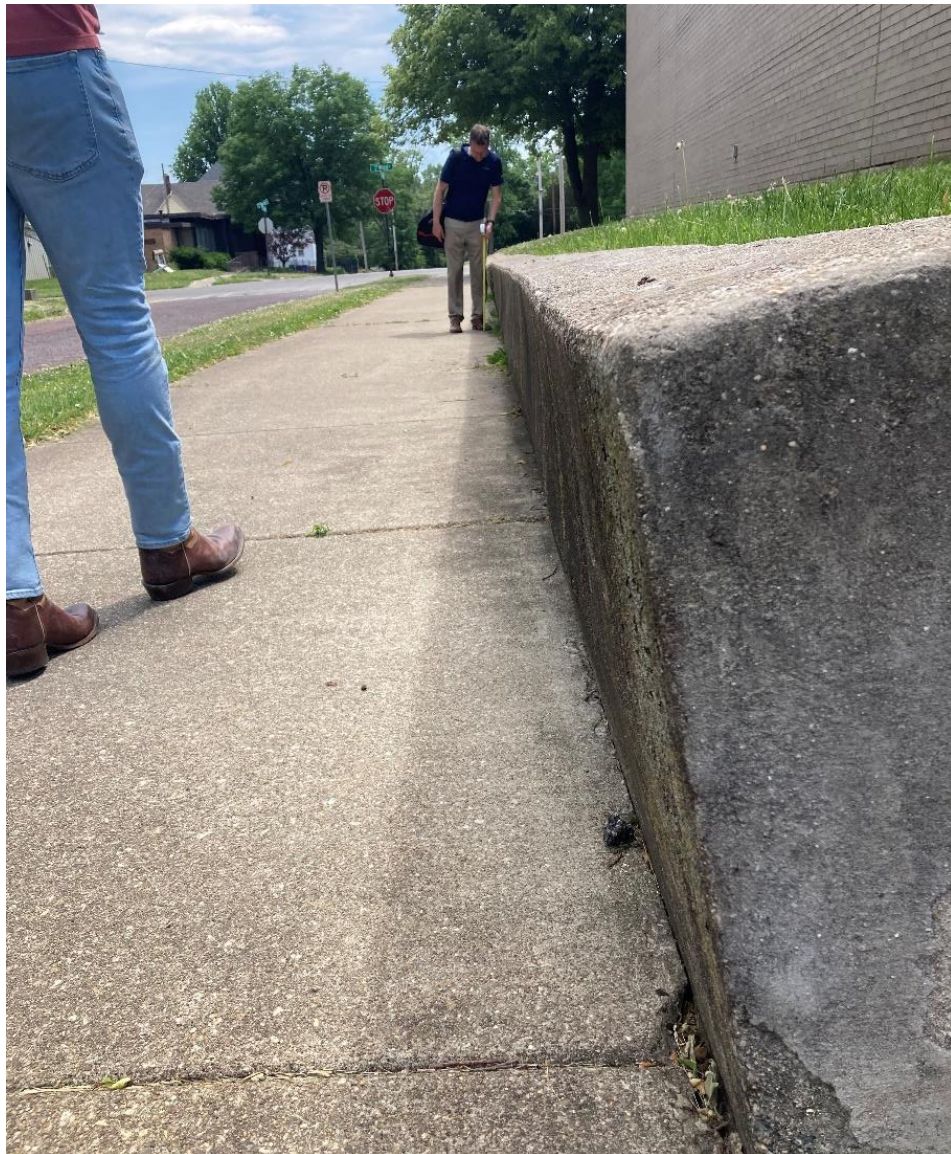
Picture 9

The following are other non-urgent structural issues that we identified. While conducting the inspection of the exterior of the building, BFW also observed the retaining wall at S College Street is no longer adequately retaining soil. It is deflecting 5 ½" which is significantly more than the allowable limit and has visible cracking along the length

(Picture 9). BFW recommends this retaining wall be scheduled to be replaced. The lintel above the exterior exit to the All Purpose Room was observed to have multiple issues. Cracking above the midspan of the lintel was observed to extend the full height of the wall above the lintel as well as cracking at the lintel bearing (Pic 10). These cracks were also evident on the exterior of the building. These are possible indications that the lintel is not sufficiently supporting the brick and CMU above the opening. BFW recommends the CMU to be repaired and the lintel replaced. Cracks were also observed on the interior of the All Purpose Room at the control joint on the North wall, on the North side of the West wall, and above the opening above the primary entrance to the room (Pic 11). These cracks should be monitored for worsening conditions. BFW also noted (3) corroded exterior lintel in rooms 317 and 311 in the original building (Pic 12). BFW recommends these lintels be replaced if they are not included in the parapet/wall repairs outlined previously in this report. Engineers also observed grout missing from the few courses of brick at the Southwest corner of the original building (Pic 13). BFW recommends this area be scheduled to be re-pointed. There is a CMU & brick privacy wall around some roof top equipment on the addition roof. These walls are susceptible to temperature swings and freeze thaw since they are not in a controlled environment. There appears to be many locations of horizontal cracking, cracking at lintel bearing, and some bulging of brick (Pictures 14-16). BFW recommends sealing cracks in these walls with a flexible sealant and setting up crack monitors. We recommend inspecting the monitors and these walls every 3 months for 1 year to see how they behave through the seasons. We feel that these walls should be reassessed after the 1-year timeframe to determine if any more drastic action needs to be taken. One eventual option might be to replace these masonry screen walls with a lighter weight prefabricated option that will not deteriorate like masonry or be as affected by thermal changes.

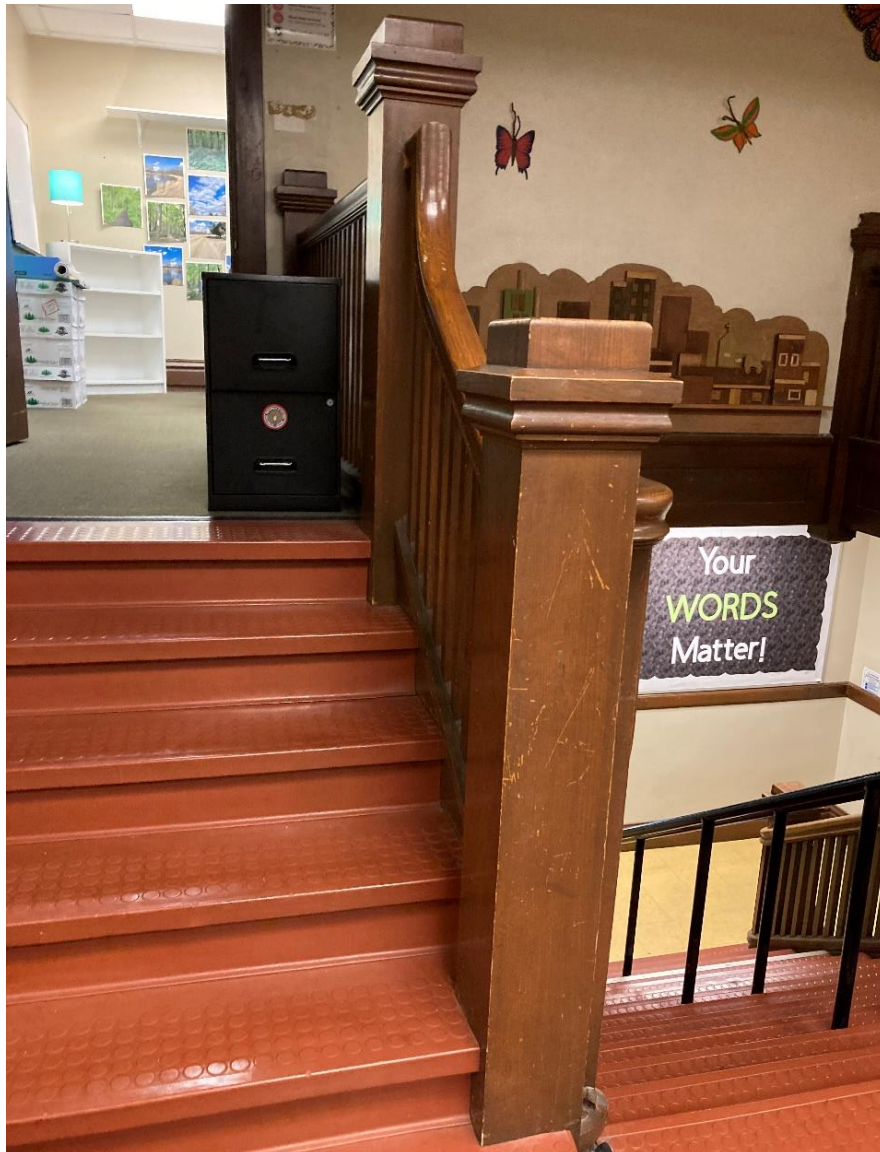
Picture 17

The interior inspection of the building was limited due to the presence of plaster walls and ceiling as well as decorative woodwork covering structural elements. BFW did note deflections of the handrails and tilting of the primary stairwell at the top level (Pic 17). BFW recommends reinforcement or replacement of the existing structural elements to be scheduled. Further investigation will be required to help determine the correct repair or how to replace it.

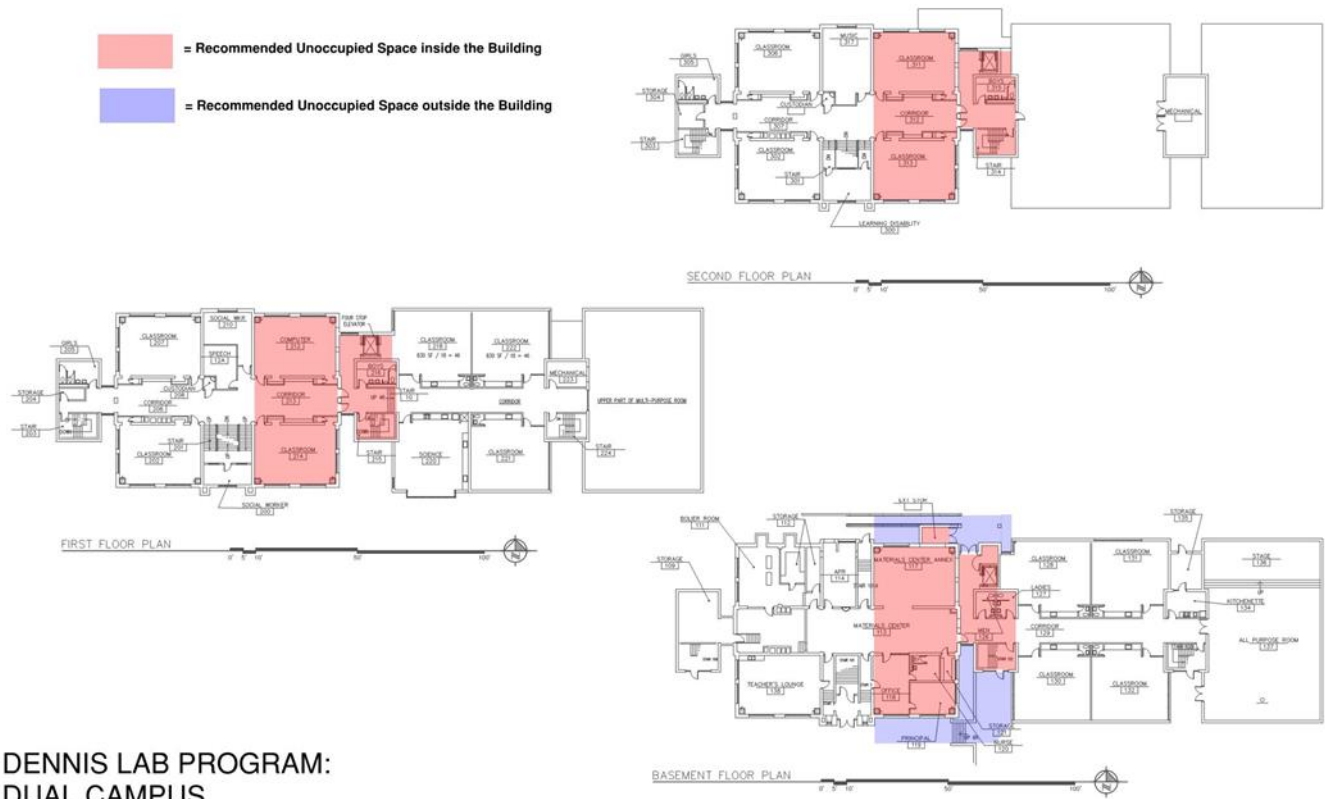
Figure 2

On the evening of the site visit, we corresponded via phone that there was an unstable portion of the building and that we recommended restricting occupancy inside and outside the building at areas adjacent to the unstable location. On the morning of May 31<sup>st</sup>, an email was sent with an attachment highlighting these areas. The attachment can also be found in Appendix A in Figure 2.
