BACON | FARMER | WORKMAN
ENGINEERING & TESTING, INC.
907 ARROW ROAD, STE 2 | CHAMPAIGN, IL 61821

06/20/2023

Re: Dennis Lab School Inspection (Mosaic)
1499 W Main St
Decatur, IL 62522
BFW Project No. 23418

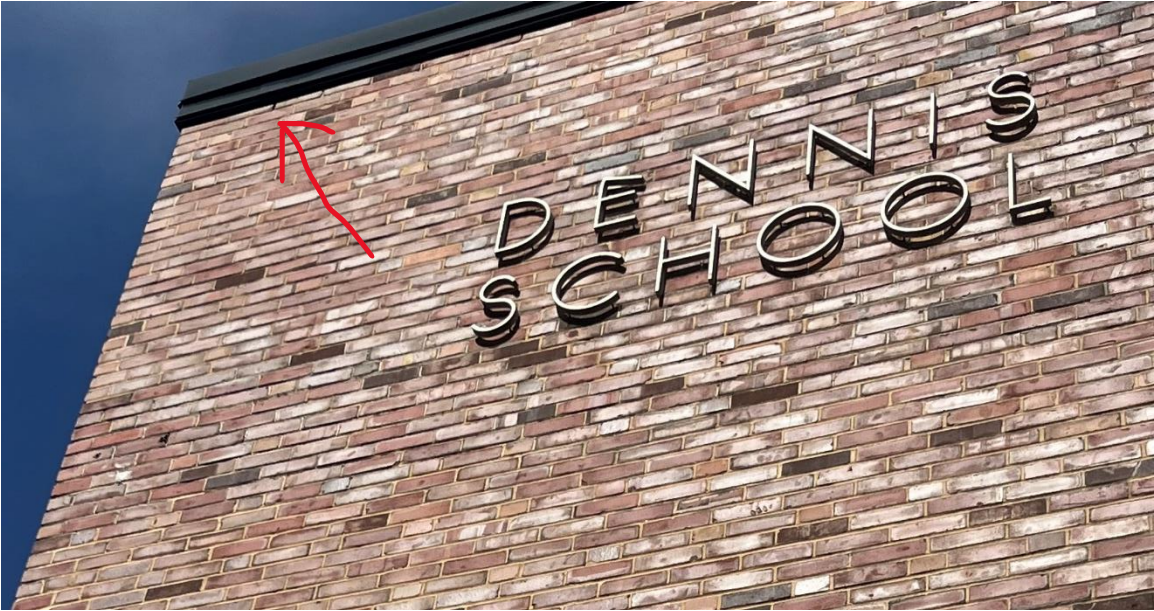
Picture 1

On the exterior of the building, minor cracking was observed at the South-East corner of room 133 at the top course (Pic 1). This area should be monitored for worsening conditions. The exterior stairs on the South side of the building show cracking at handrail post locations and the handicap lift showed signs of corrosion (Pic 2&3). While the stairs and lift do not currently lead to a doorway and do not appear to be in use, it would be BFW's recommendation that they be roped off or removed. We recommend that the crack at the handrail be filled with a flexible sealant. A pipe was observed sticking out of a window in room 141 for drainage. The current outlet is a few inches from the face of the building and the water drainage is undermining the grout in the structural brick (Pic 4&5). BFW recommends that an extension be placed on the outlet to let water drain away from the face and foundation of the building and grout be replaced where missing. The retaining wall along the West side of the building near the road is not adequately retaining soil. It leans more than the allowable limit and has visible cracking along the length (Pics 6&7). BFW recommends this retaining wall be scheduled to be replaced. The brick knee wall at the west entrance is missing mortar along the base (Pic 8). BFW recommends that mortar be replaced at these locations. Cracking and split bricks were observed near the foundation at the South-West corner of the stage (Pic 9). This is likely caused by the water

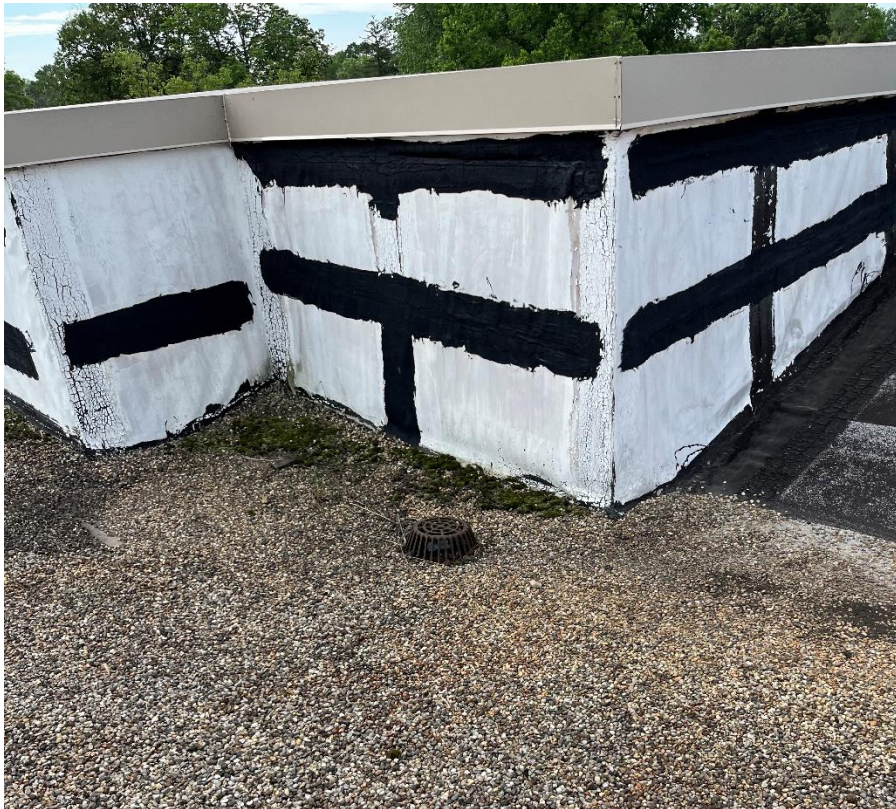
Picture 11

The roof of the building was overall in good condition. The roof slopes are not adequate to provide necessary drainage at all corners of the original building. Evidence of ponding was present (Pic 11) and should be carefully monitored to ensure standing water does not remain on the roof. Roof drains should be adequately inspected to ensure proper drainage is achieved. Corrosion was observed on the frame supporting the large roof top unit (Pic 12). This is due to water drainage from the RTU being directed toward the structural elements (Pic 13). BFW recommends that an extension be added to the outlet to direct drainage directly to a roof drain. BFW also recommends a corrosion inhibitor be applied to the corroded steel and maybe a new finish applied.

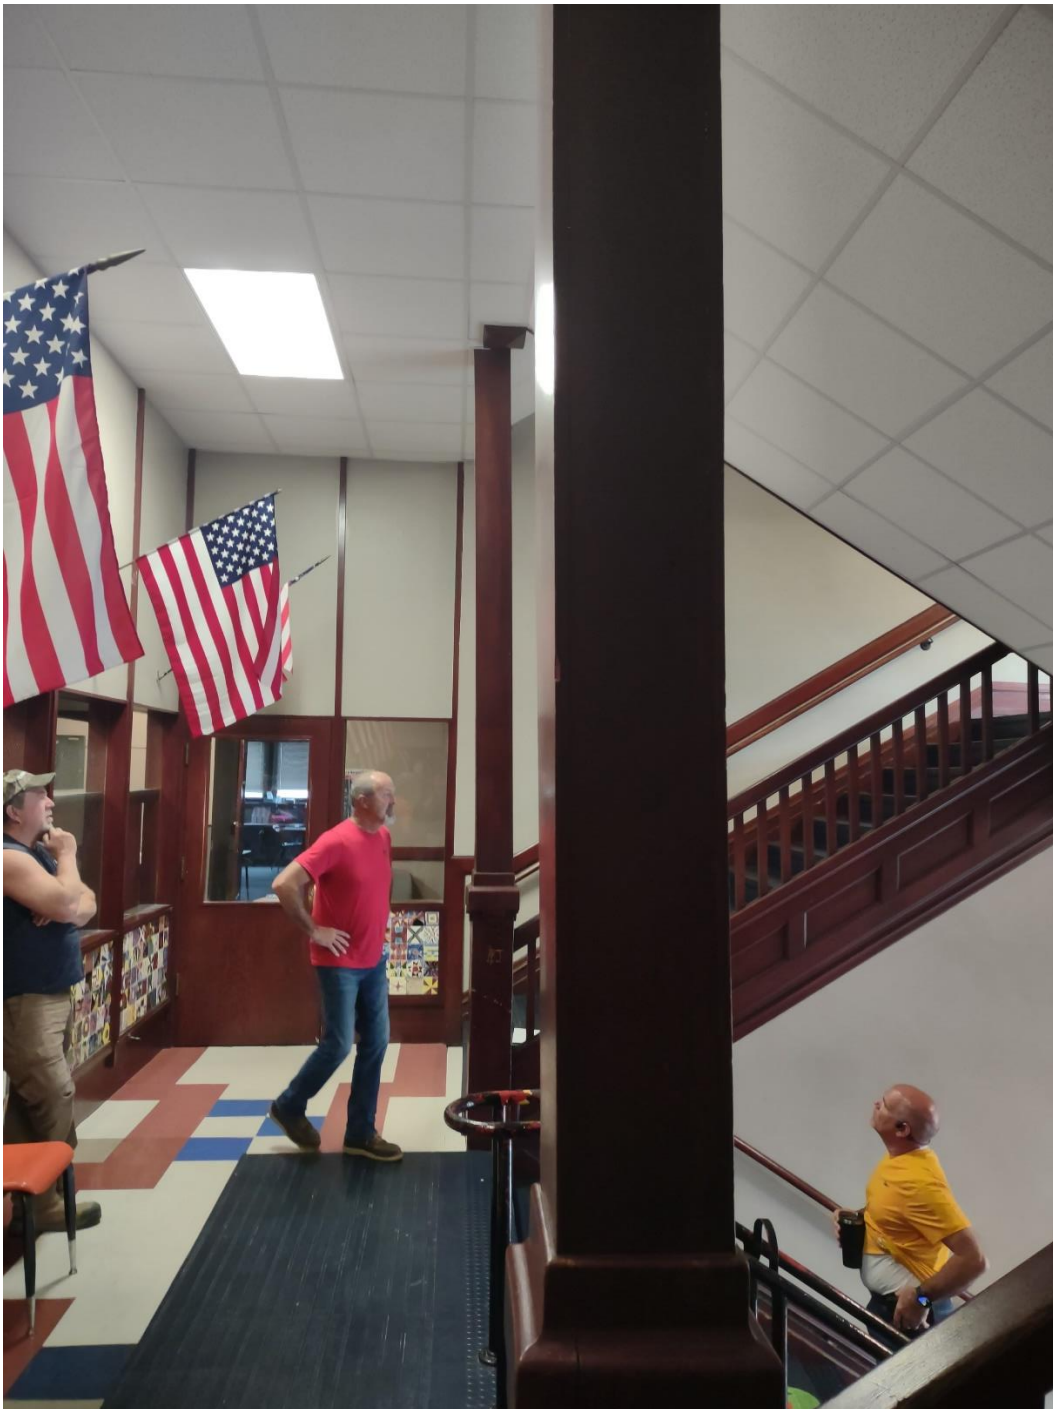
Picture 14

The area of greatest structural concern in this school was observed at the North stairwell of the original building. The main flight of stairs from the main level to the second level were vertically sagging along the mid span and worse against the west side of the stairs where the stairs were clearly deflecting and leaving a gap between the trim (Pic 18). We removed a section of ceiling below this area, and it was evident that some previous sistering of stair framing had been done in the past, but the sistering did not extend to the bearing point (Pic 19). We were also told while on site that some other stair joists have had to be reinforced in the past. On the second floor there are two columns that bear where the stairs turn and extend upward. These columns support the third-floor stairs and landings. These two columns appear to be approximately 6x6 wood posts with wood cladding on the outside. These columns were leaning about 2 ½" along their height toward the south which is more than the allowable deflection amount per IBC 2015 (Pic 14). The two stairs and walkways on the third floor that extend for access to Toilet Room 304 & Reading Room 306 are sloping/tilting in two directions (Pic 15) and the railings are leaning outward (background of Pic 17). Wood cladding is cracking at these two locations as well. A steel beam supports the south edge of Toilet Room 304 & Reading Room 306 and the north end of these sloping/tilting landings. While the deflection did not visibly appear based on the visible wood cladding, there is a crack in the plaster at the midspan of this steel beam support which might mean that the support beam is deflecting more than what the wood finish is showing (Pic 16).

BFW recommends all levels (landings and flights) of this main north stairwell to be closed off to occupancy until further structural investigations and repairs/replacement can be provided due to the above-mentioned concerns at stair framing, landing framing, railing, and columns. The restroom and Reading room at the third floor above the stairwell should also be closed as they are supported by the members of concern. If repairs are desired, then BFW recommends ceiling and cladding demo to visibly access all structural framing and members to aid in analysis for repairs/reinforcement to be designed. If replacement is desired, then we recommend exploratory demo to aid in temporary shoring plans and design documents.
